LEVEL II ENGINEERING MANUAL

FOR MCMURDO STATION

Sponsored by
U.S. NAVAL SUPPORT FORCE, ANTARCTICA

CIVIL ENGINEERING LABORATORY
Naval Construction Battalion Center
Port Hueneme, California 93043

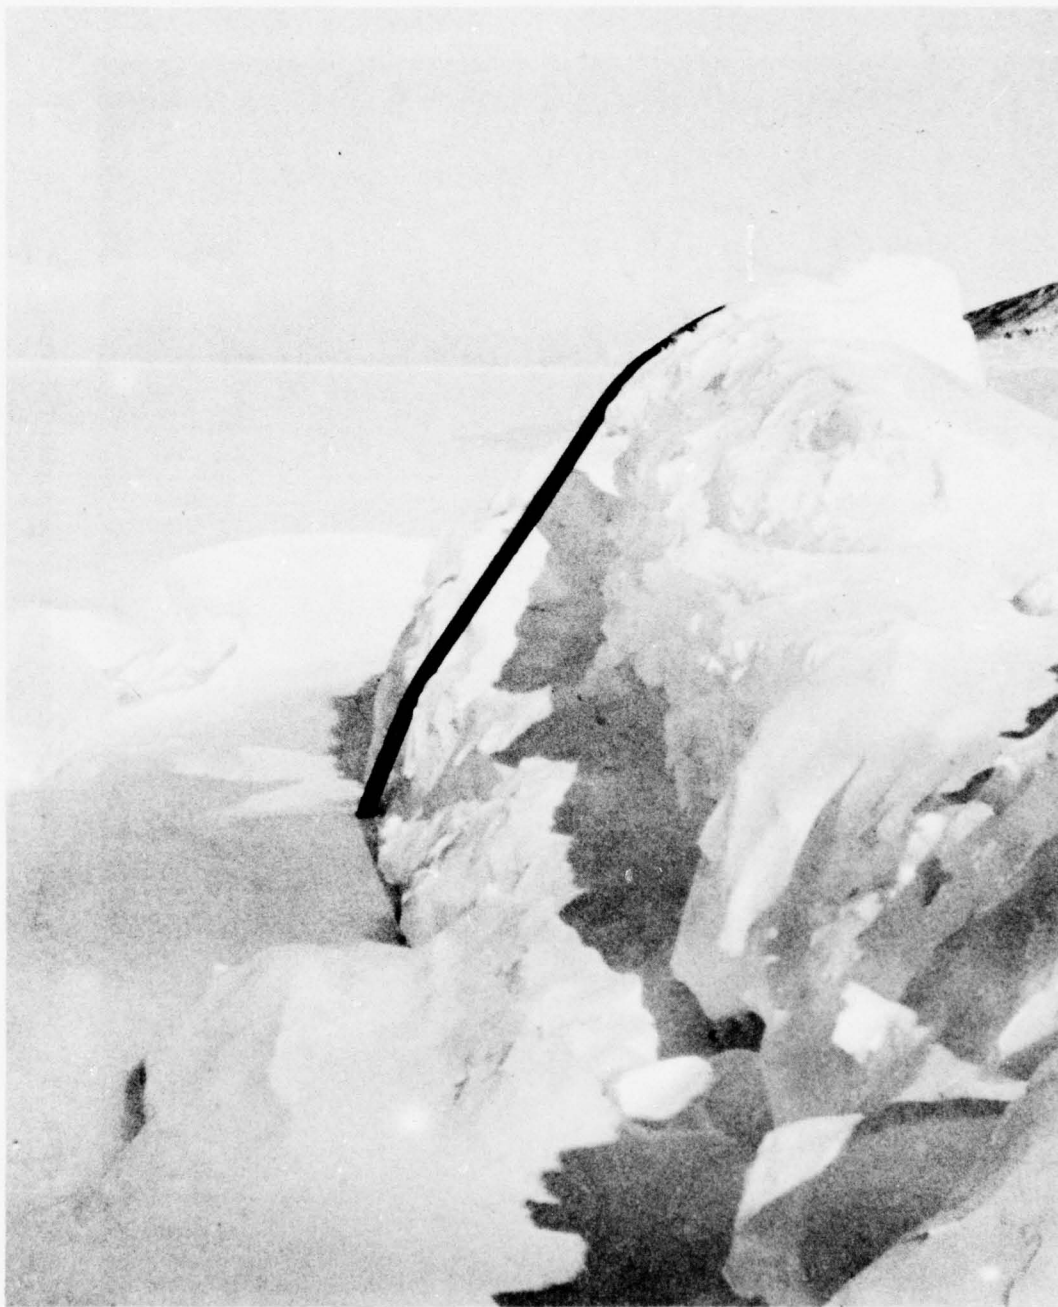
Figure 1-15. Hazardous pressure ridge and slush pool between Scott Base and Cape Armitage.

D. A narrow zone of intensely ridged and broken sea ice forms each season in the area between Scott Base and Cape Armitage (Figure 1-15). These pressure ridges, along with downwarped, flooded areas, usually occur at the sea ice-to-land contact and are easily avoided because of their prominence.

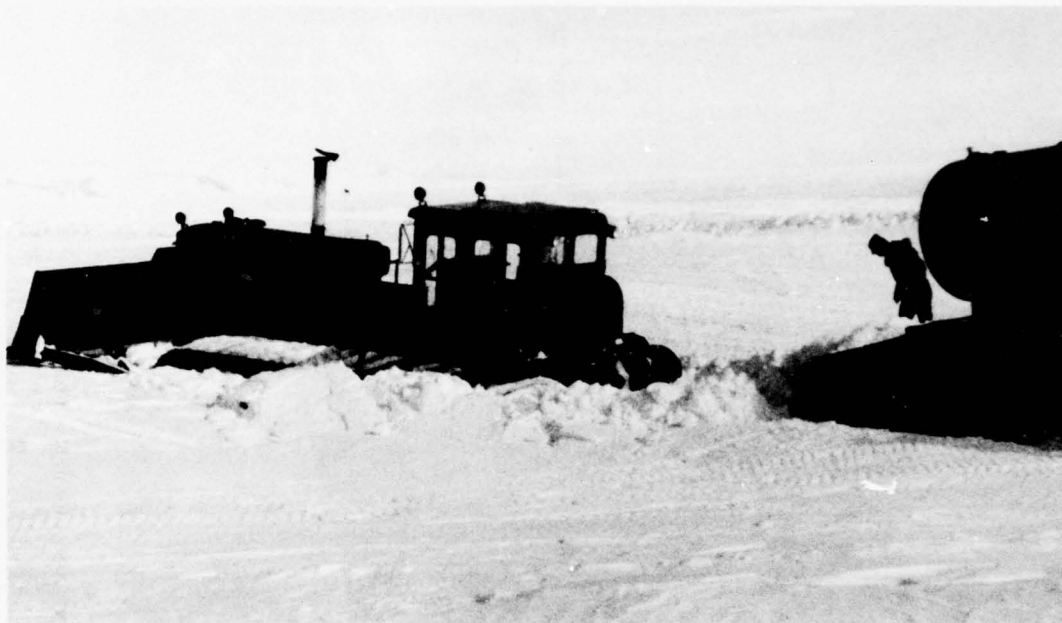
Figure 1-16. LGP-D8 tractor immobilized in slush pool covered by dry snow on sea ice between Scott Base and Cape Armitage.

Slush zones also form in this area and are different from the slush pools associated with pressure ridges. Slush zones form in the area between Scott Base and Cape Armitage where the snow cover is often more than 1 foot thick. By midsummer, large areas of snow may become flooded with seawater to form strengthless slush. Flooding is usually caused by tide cracks or seal breathing holes. Slush zones can be several hundred square yards in extent and may not be visible because of an undisturbed crust of wind-packed snow. Vehicles can break through the crust and become stuck in the slush (Figure 1-16).

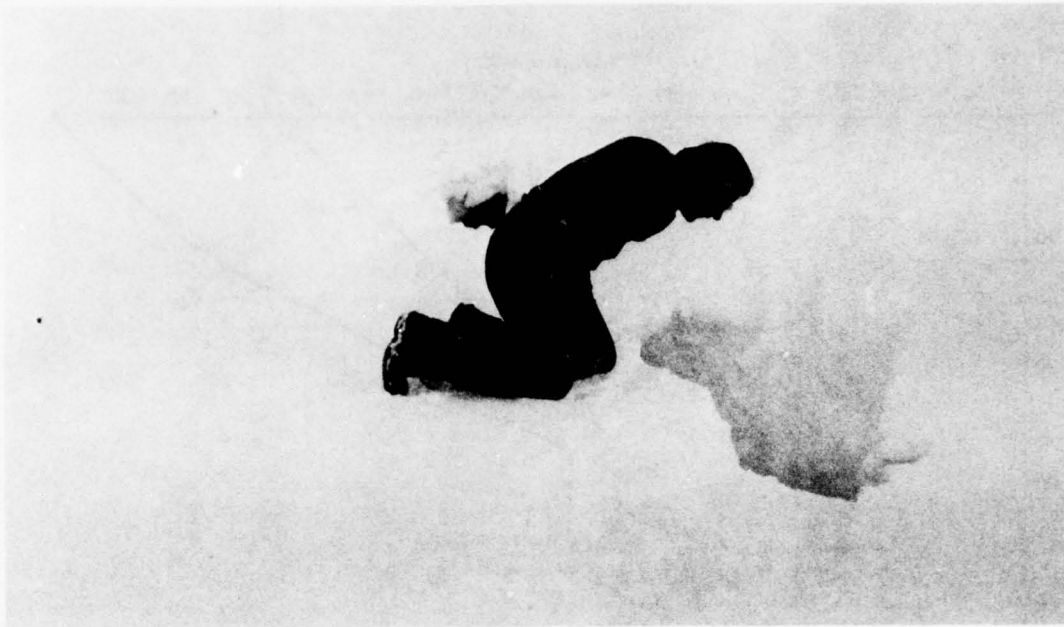
Figure 2-8. Crevasse in McMurdo Ice Shelf south of skiway.

changes in its dimensions from season to season are considered typical of crevasses in the area. In DF-64 this crevasse was about 3 feet wide (Figure 2-8). By DF-68 it had widened to 6 feet at the widest point and was found to extend about 1,000 feet east at right angles to the barrier face. Early in DF-69 it had begun to close and was only 2 to 4 feet wide. In cross section it was wider at the bottom and was floored with sea ice during most of the year. The snow bridge covering the crevasse varied in thickness from a few inches to 12 inches and often sagged downward during the summer, thus warning of its presence.

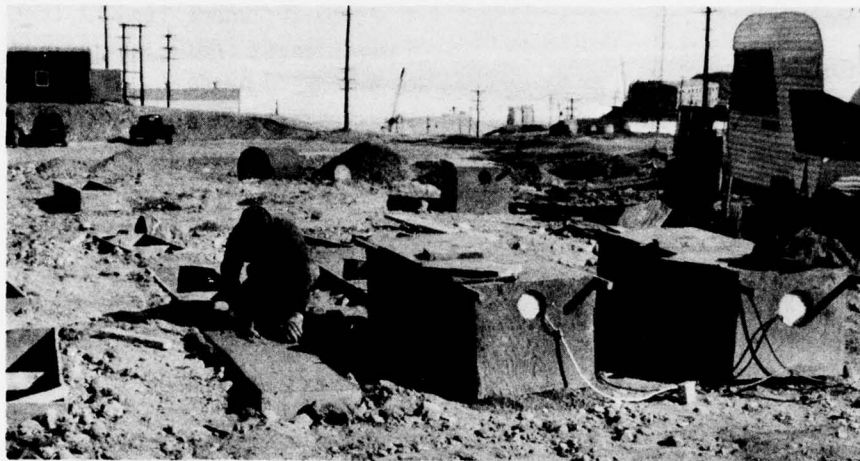
Concrete cast at McMurdo Station, Antarctica, is heat cured by using wooden boxes in which an electric element supplies the heat and a fan circulates the air.

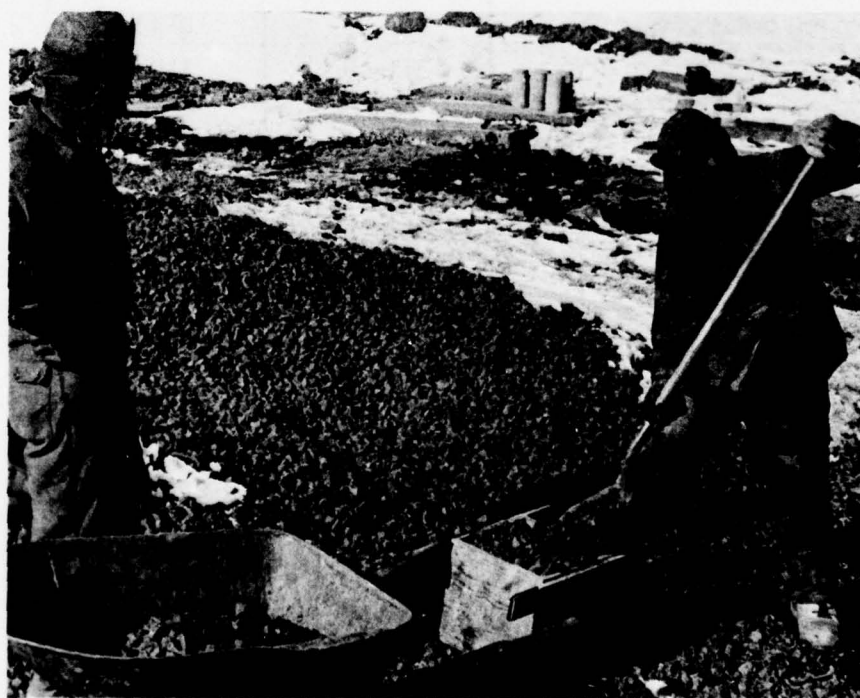
Batching rock by volume container (1 ft³).

which are known to contain certain weights of the ingredients when loosely filled. For example, a 1-ft³ box can be loosely filled several times with rock and weighed and the weight of rock determined on an average basis. Thereafter, the container, filled with rock in the same manner, may be considered to contain the same weight of rock each time. The same procedure may be used to batch sand and cement. If desired, the rock and sand for a given batch may be stored mixed together and protected from direct precipitation; the cement should be stored separately and kept dry.

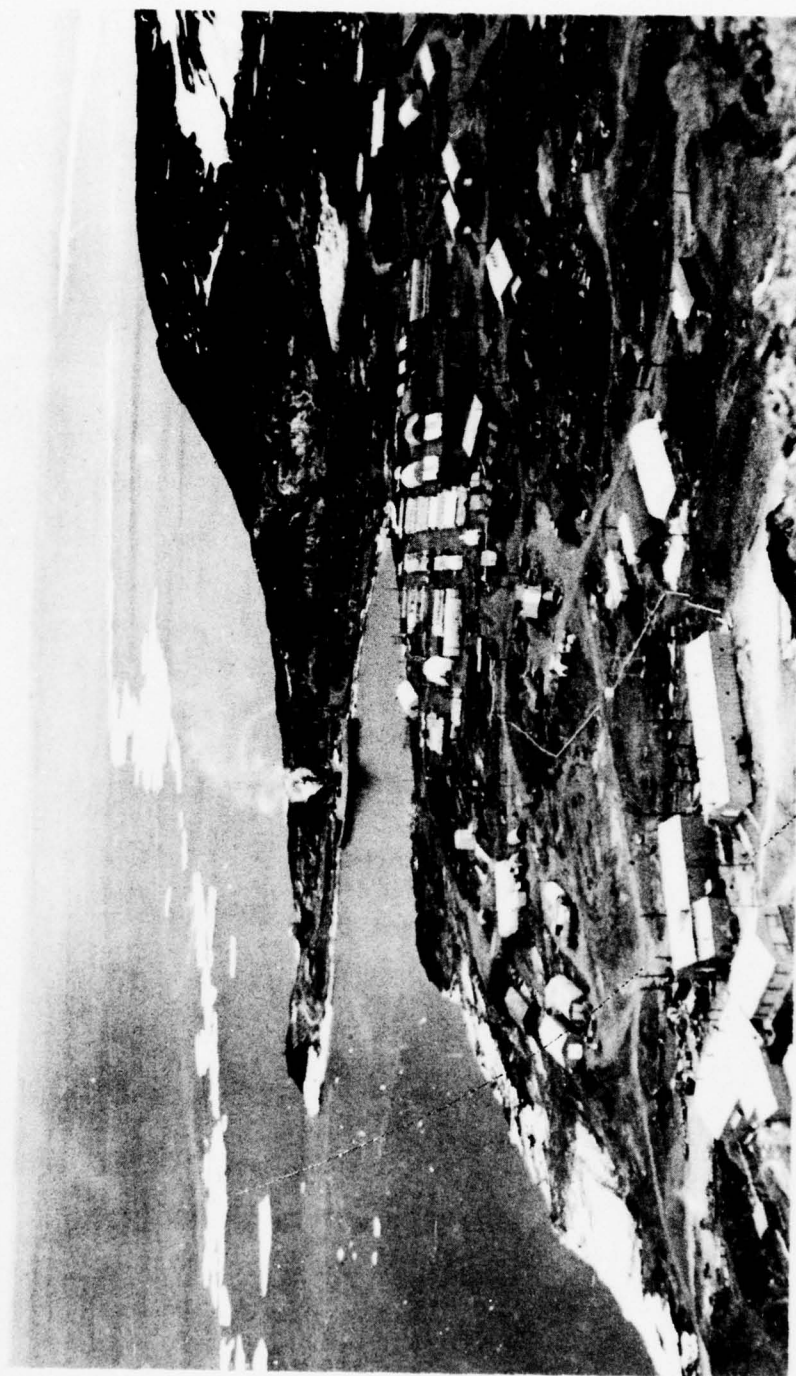
Figure 8-1. View west over McMurdo Station, Winter Quarters Bay, Hut Point, and McMurdo Sound, DF-66.

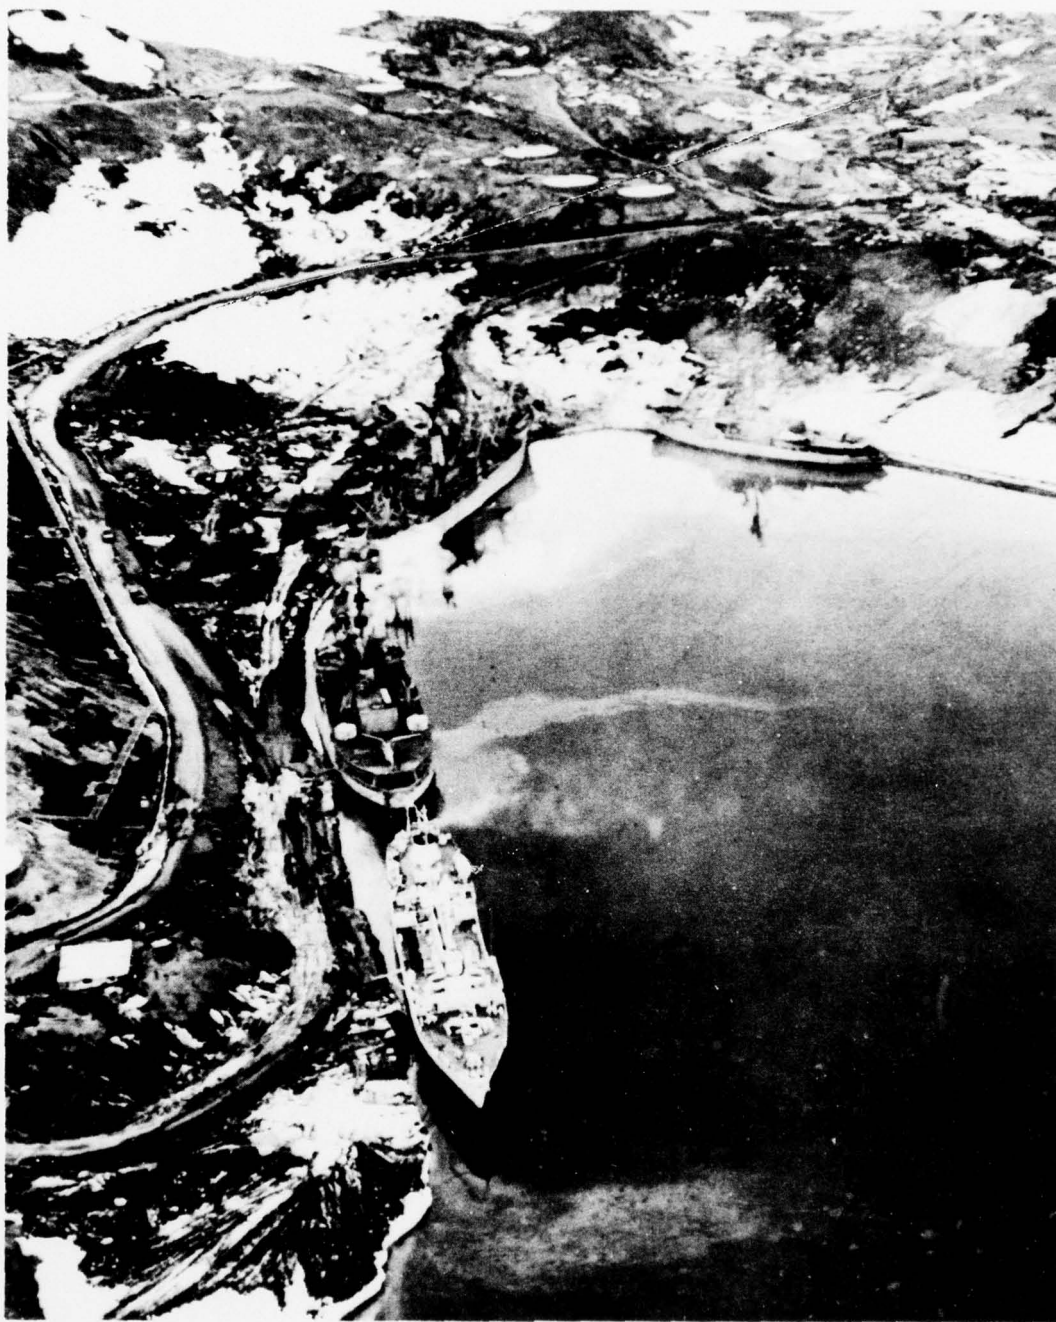
Figure 8-2. Ships docked at ice wharf in Winter Quarters Bay (January 1966).

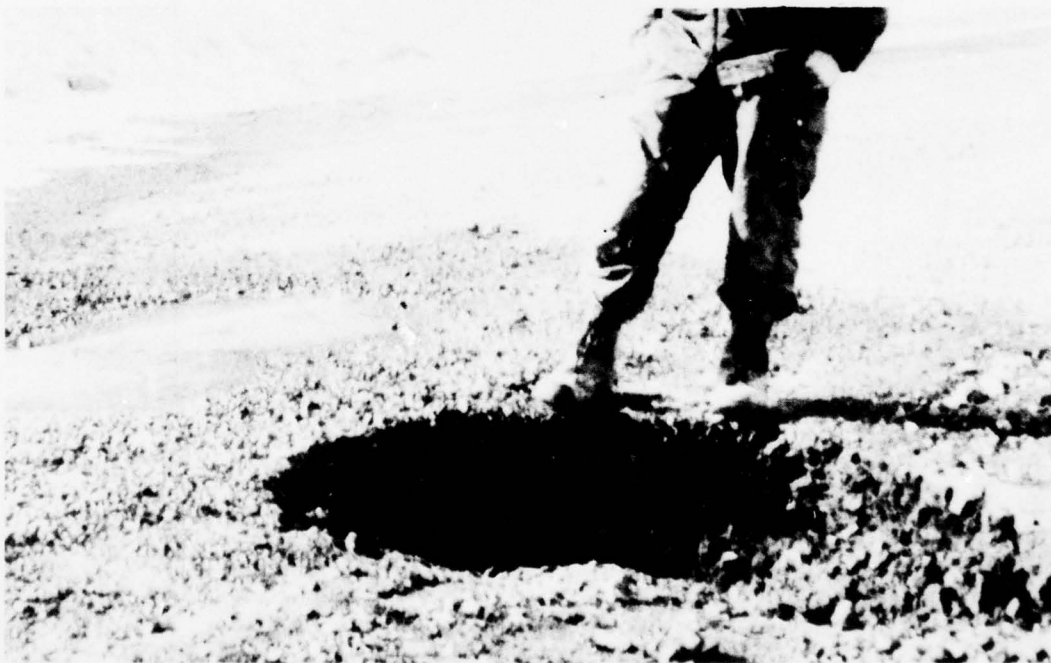
Figure 8-7. Pothole formed in surface of the wharf by subsurface melting and collapse.
